“There are 2 kinds of Mooney, ones that leak and ones that don't leak yet”. I've heard that many times but our experience was only with dry ones. The Mooney that I will speak about is a 99' M20R Ovation and is the first one that has an issue with its fuel tank among the 6 Mooneys we've operated in our aeroclub in France since 1988. We've had 4 M20J and 2 M20R Ovation I.

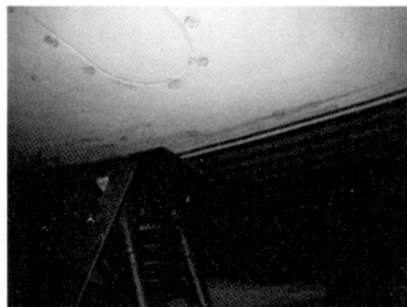
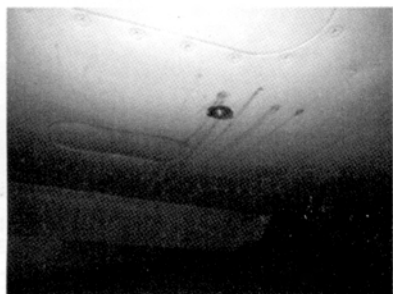
The Ovation started to leak one and a half year ago on the top of the right wing and under it as well. It started with small spots around rivets and ended with fuel trails at the wing skin junction and also with a peeling wingwalk.

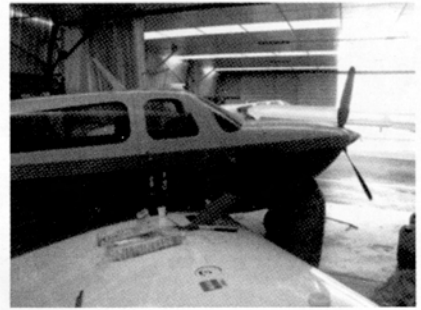
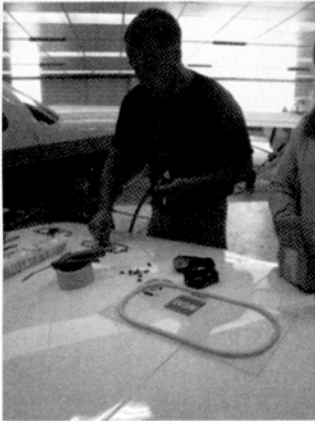
I learned from him, that the key to fix this problem is to precisely identify the origin of the leak. For example, if it weeps under the wingwalk, that means that the leaks starts far away from that point, because there is no fuel storage under the wingwalk. To identify the fuel itinery from the tank to the outside, Paul has designed special tools to see inside the tank while applying vaccum and

pressure to the tank. This way he can put the sealant exactly where it must be. By the way, he uses 2 different sealants depending on the size of the spot. When you see him at work, you understand that he is an expert at doing it.

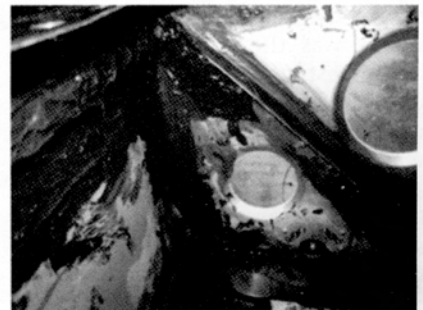
When Paul opened the wing for the first time he found a real mess in it. The Service Center in Europe sprayed an inappropriate thick sealant into the wing tank and as a result it created bubbles and holes causing the fuel to run between the skin of the tank and the sealant itself.
